**SYSON-HILLE
and
ASSOCIATES**

July 14, 2008

Re: **POWLEDGE vs. GENERAL MOTORS CORPORATION**

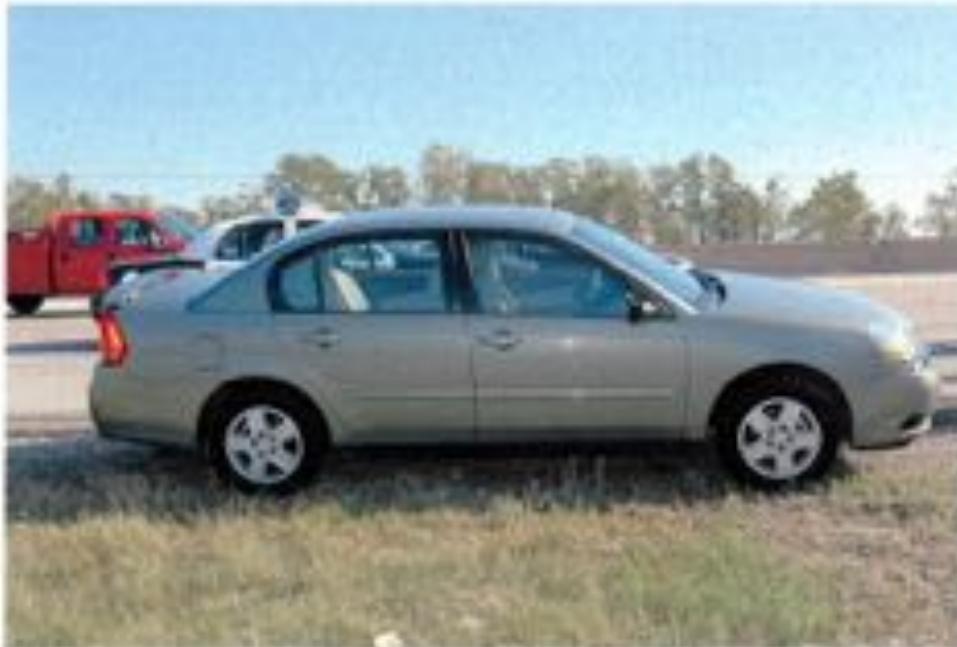
- F. Mr. Powledge was able to steer and control his vehicle and thus avoided striking several vehicles that were on I-45. He managed only to slightly sideswipe another Malibu side mirror to side mirror before leaving the travel lane of I-45 and entering the grass median. Damage to the other Malibu is shown below:

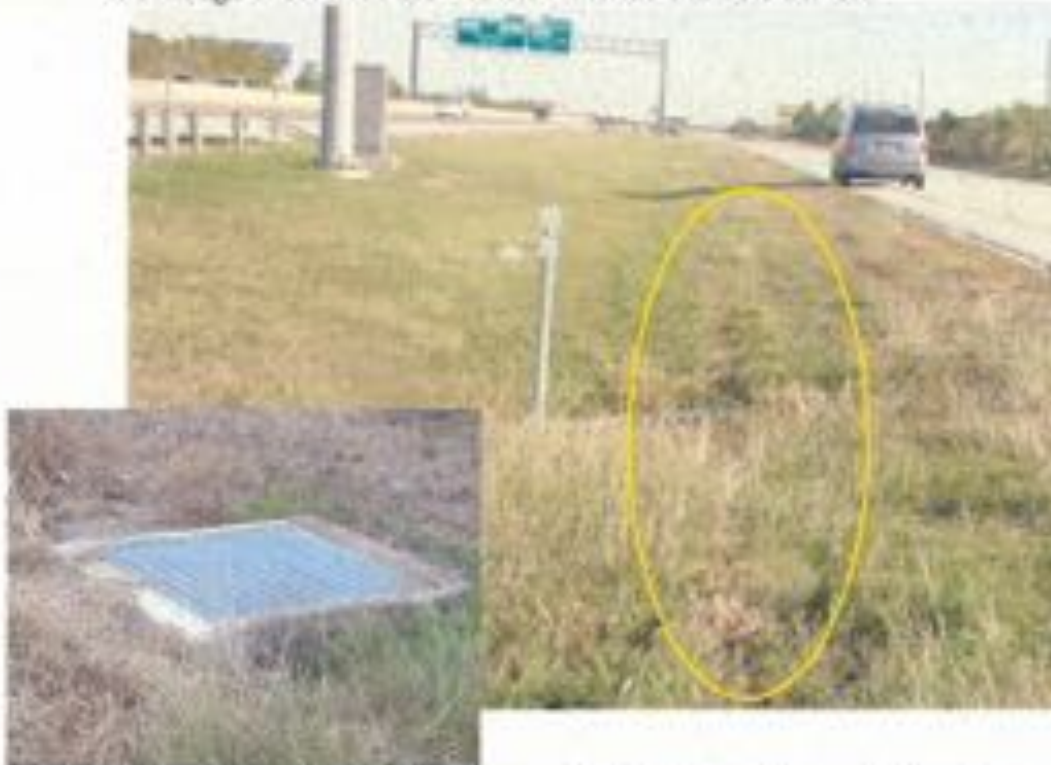
- H. Photographs provided by Laurie Williams that were taken by her husband Michael 7 days after the accident still clearly depict the tire marks made by Mr. Powledge's vehicle. The Williams' photographs and the Scientific Analysis photographs taken October 30, 2005 reveal that as Mr. Powledge reached the far side of the median after avoiding the obstacles described above, he contacted the top of a cement and steel drainage culvert with his left side front tire. This culvert was never photographed by the police or mentioned by the police in the scene diagram. The culvert has a sharp edge that is several inches tall. Measurements by Scientific Analysis taken on October 30, 2005, revealed that the centerline of Mr. Powledge's left front tire was 1.3' into the concrete culvert.

- I. The concrete culvert edge damaged the left front inner wheel and punctured the tire. The wheel and tire damage affected Mr. Powledge's ability to steer and control his vehicle.

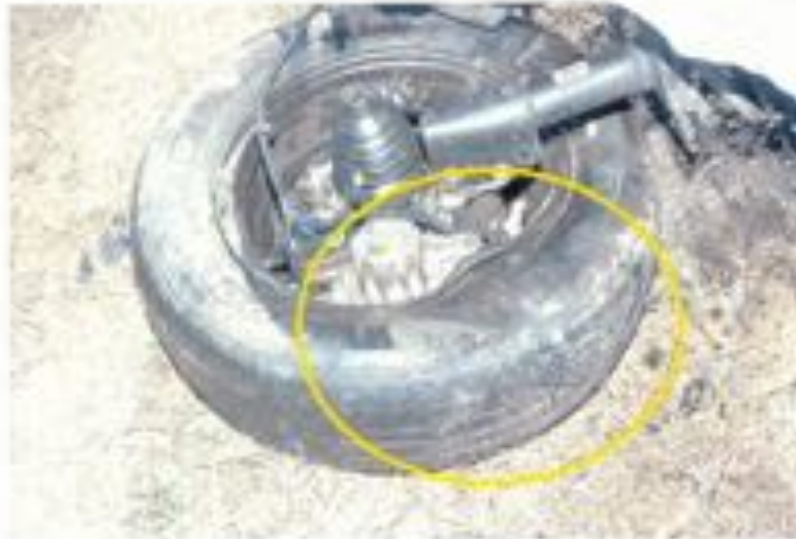
- J. The contact with the drainage culvert is evident in a police photograph where there is clearly a "curb strike" type dent in the rim and a large cut in the tire at the same position. This event would have rapidly deflated his left front drive tire and immediately pulled the Powledge vehicle back to the left (toward the middle of the grass median).

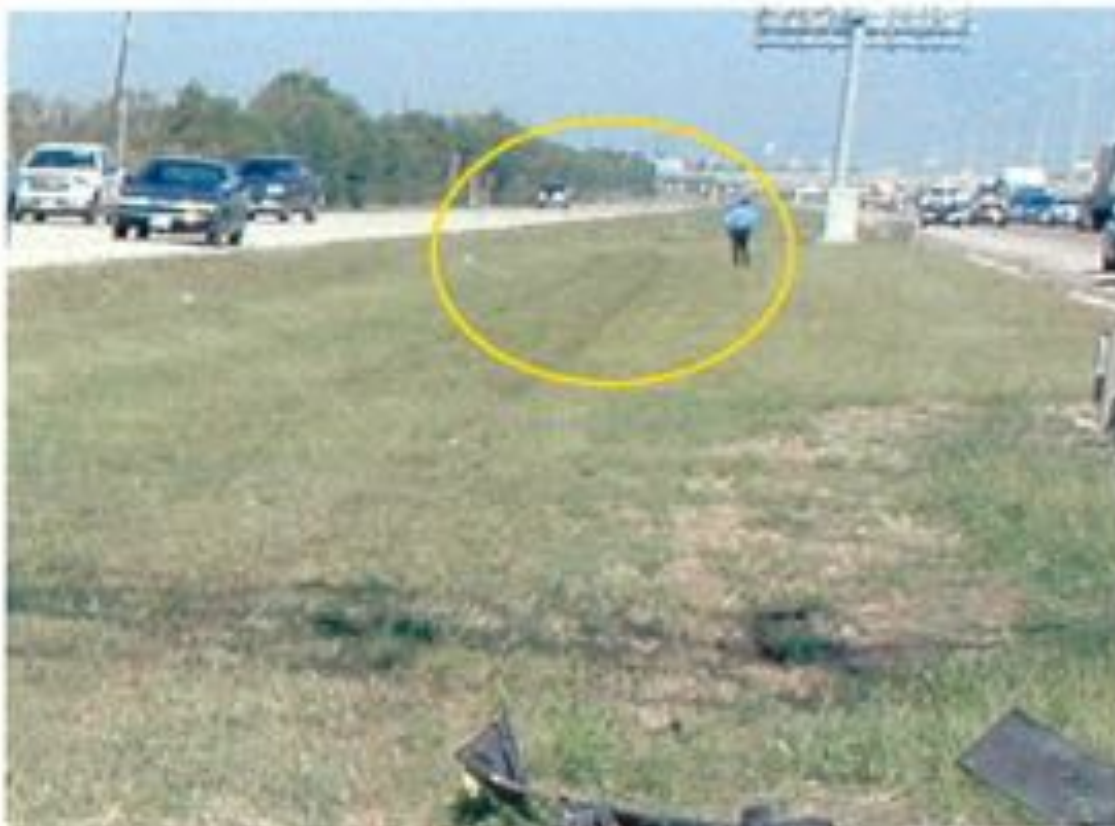
The re-directed motion of the vehicle back to the left (middle of the median) is evident in numerous photographs. As Mr. Powledge's vehicle moved left toward the flow line of the median and the deflated tire and bent wheel affected his steering and control capability, these conditions would tend to straighten out the vehicle into the lowest portion of the median.

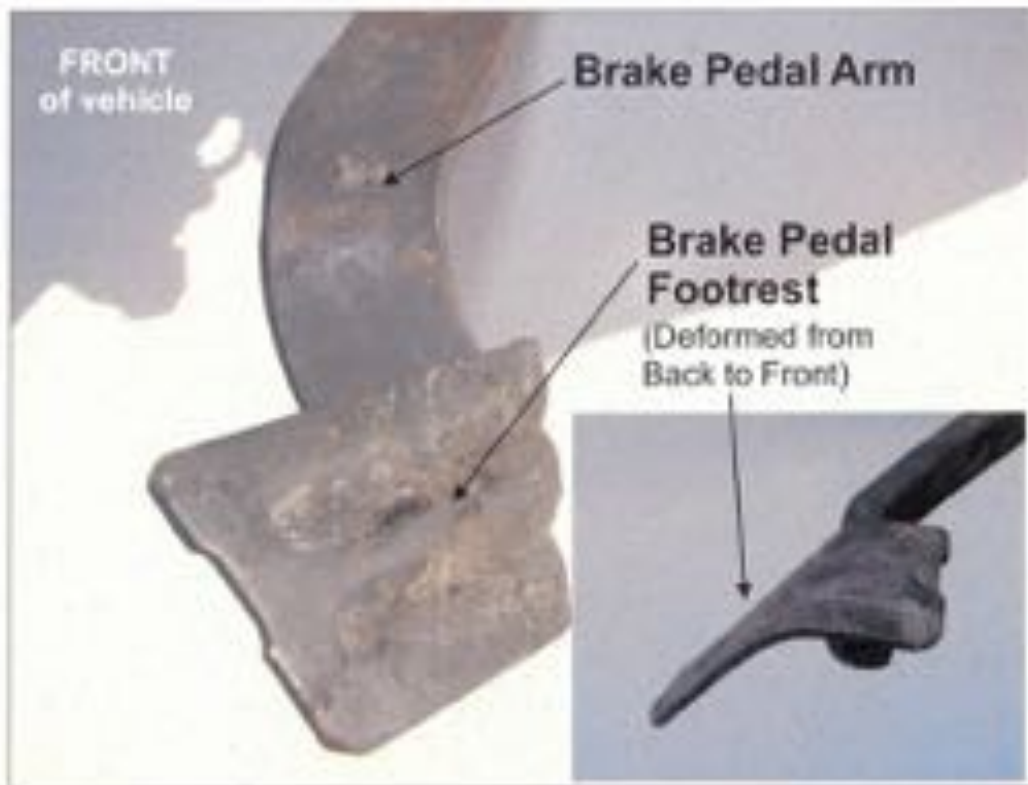
- Q. During one of my many inspections of the subject vehicle, the brake pedal was located. The brake pedal has significant deformation in the forward direction. In other words, the flat part of the pedal that your foot applies pressure to is bent from the rear to the front of the vehicle. This almost conclusively proves that Mr. Powledge had his foot on the brake pedal at the time of the impact. If Mr. Powledge was trying to commit suicide, it does not make sense that he would be applying his brakes at the moment of impact.

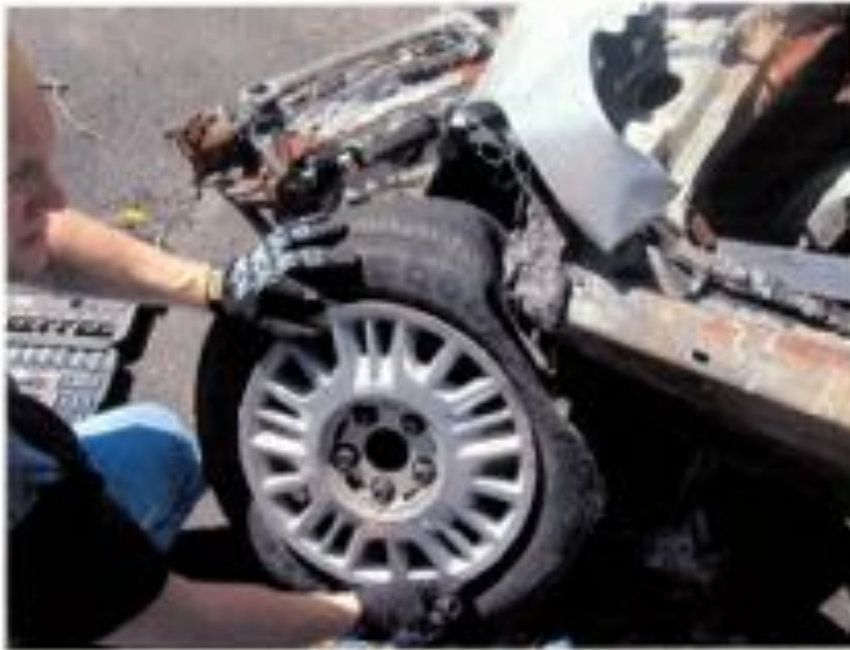
- P. The left front brake pads on the subject vehicle were overheated, despite there being little or no fire damage to that part of the Malibu Classic. In fact, the rubber tires are still intact.

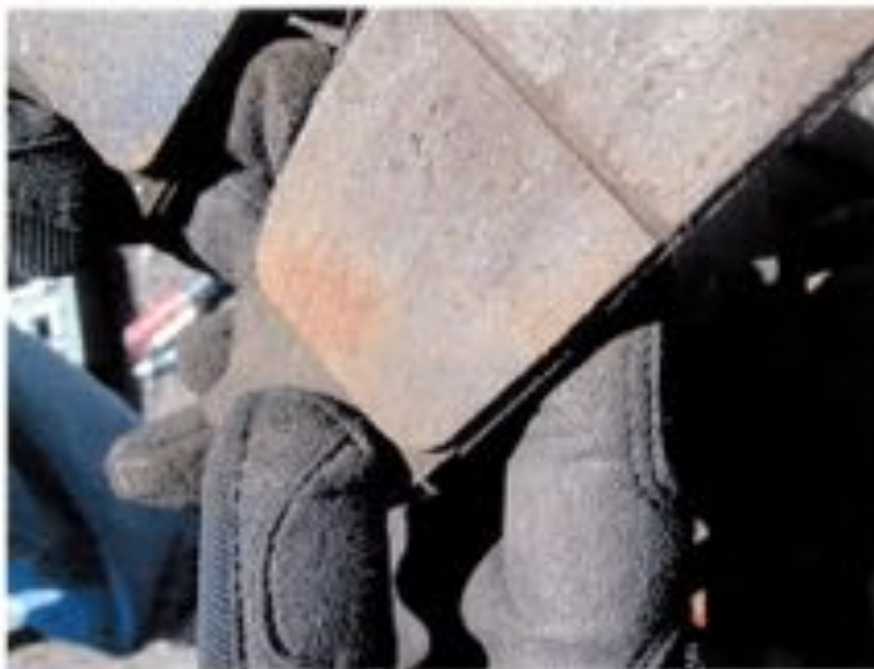
- Q. The brake pad material is overheated and spalled, indicating hard brake/pedal application. If Mr. Powledge was trying to commit suicide, it does not make sense that he would apply his brakes to this extent before the impact.

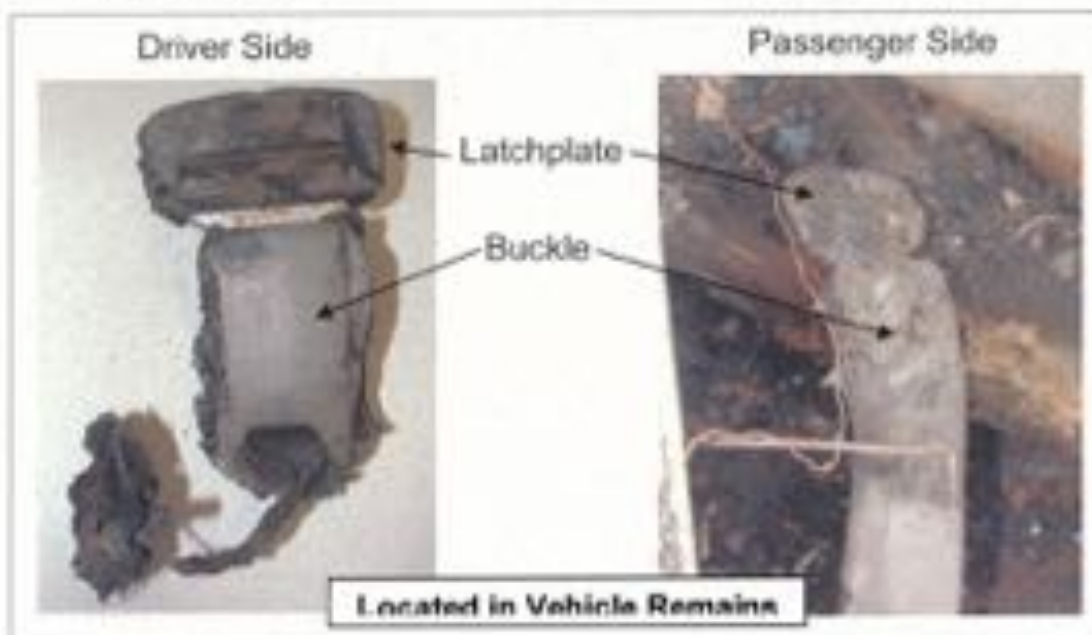
R. The driver's latch plate and buckle was located among the debris. The driver's latch plate is still in its respective buckle. It does not make sense that a person predisposed to killing himself in a vehicle crash would buckle up for safety before killing himself.

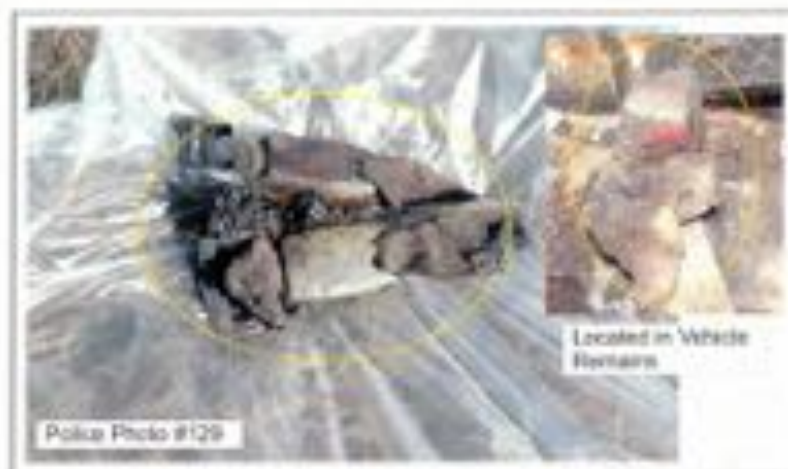
- S. Further, the buckle from the right front and one buckle from the rear seat were located in the debris. The latch plates were likewise in place in each of these buckles. Photographs taken by the police have the other two rear seat buckles documented. Again, the latch plates are inserted. It does not make sense that a man intent on killing all of his children would make them buckle up for safety before he killed them in a vehicle crash.
- T. The police report indicates that seat belt status was "unknown." However, the evidence proves that all 5 occupants had their seat belts buckled at the time of the accident.

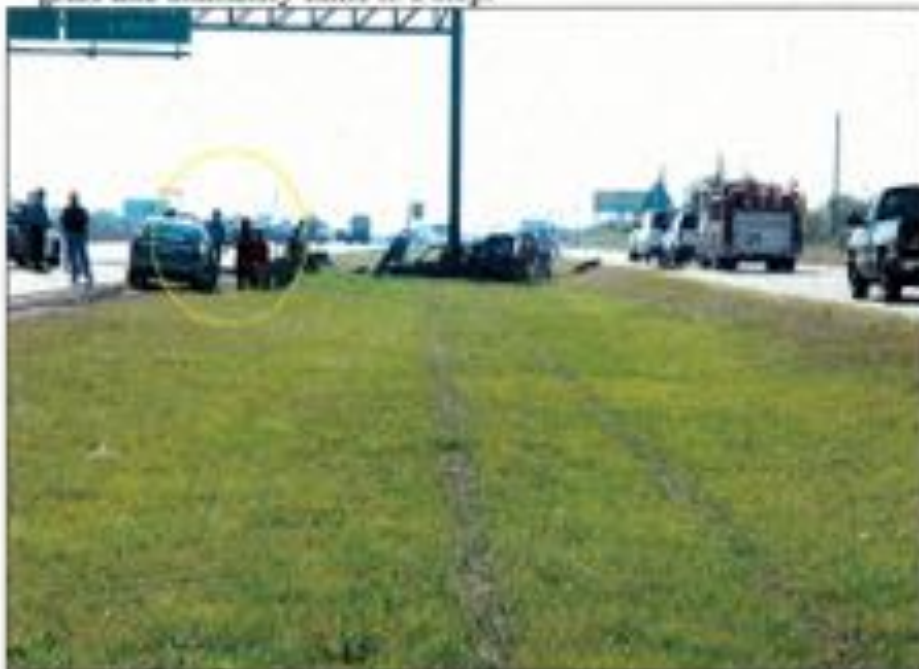
Lastly, the police photos show that the tire marks left in the median grass from the subject vehicle appear very heavy and defined. Photographs taken 7 days after the accident still show the distinct tire marks and the torn grass and disrupted soil. The subject vehicle, a front-wheel drive with anti-lock brakes, would have a tendency to drag the rear tires along, while braking under full throttle (the rear not subject to the engine driveline). The rear tires would, however, be rotating, disrupting and tearing the soil and grass surface more so than just traveling at a high rate of speed with no braking. By contrast is the Malibu, whose side mirror was struck by Mr. Powledge's vehicle during the accident that had pulled off into the median after being struck. The struck Malibu left no tire marks in the grassy median shown in the police photo, and we know it pulled onto the grass and ultimately came to a stop.

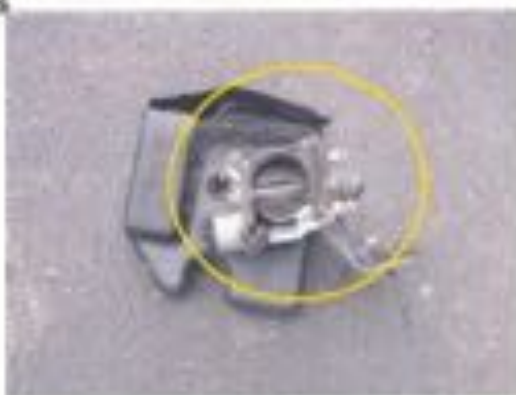
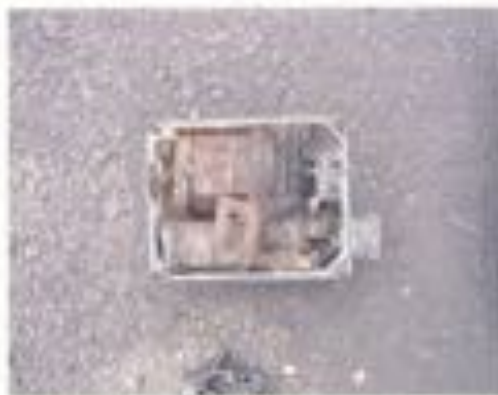
- I. I examined the remains of the vehicle to determine what was left of the power train. I found that both the engine and transmission had separated from their mount, and that both the engine and transmission had collision and fire damage. The intake manifold had either burned or broken off; however, the throttle body was located in the debris. It was stuck at the near full throttle position. There was a throttle cable connection, and a cable connection for a cruise control.
